# **U.S. 301 PROJECT DEVELOPMENT**

## **DETERMINATION OF ELIGIBILITY REPORT**

**St. Georges, Pencader, and Appoquinimink Hundreds,  
New Castle County, Delaware**

## **Volume II: Narratives and CRS Forms for N05191 to N13309**

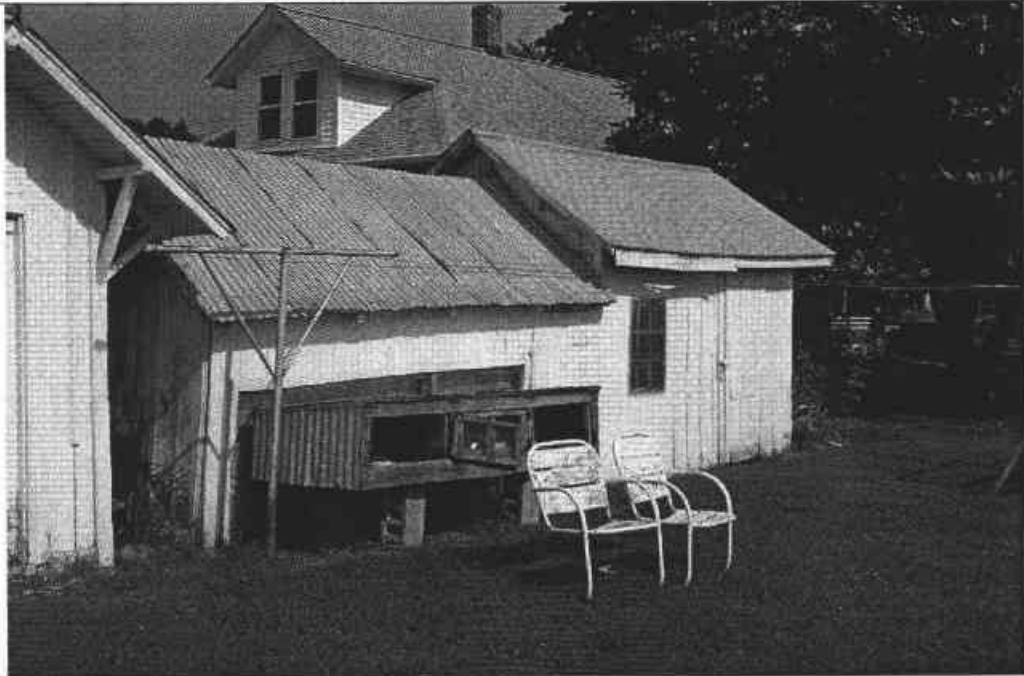
N12018. Photograph 3: Chicken house/shed, east elevation, view to west. This domestic outbuilding is representative of other early-twentieth-century buildings on the property. A tool shed is visible on the left side of the photograph.

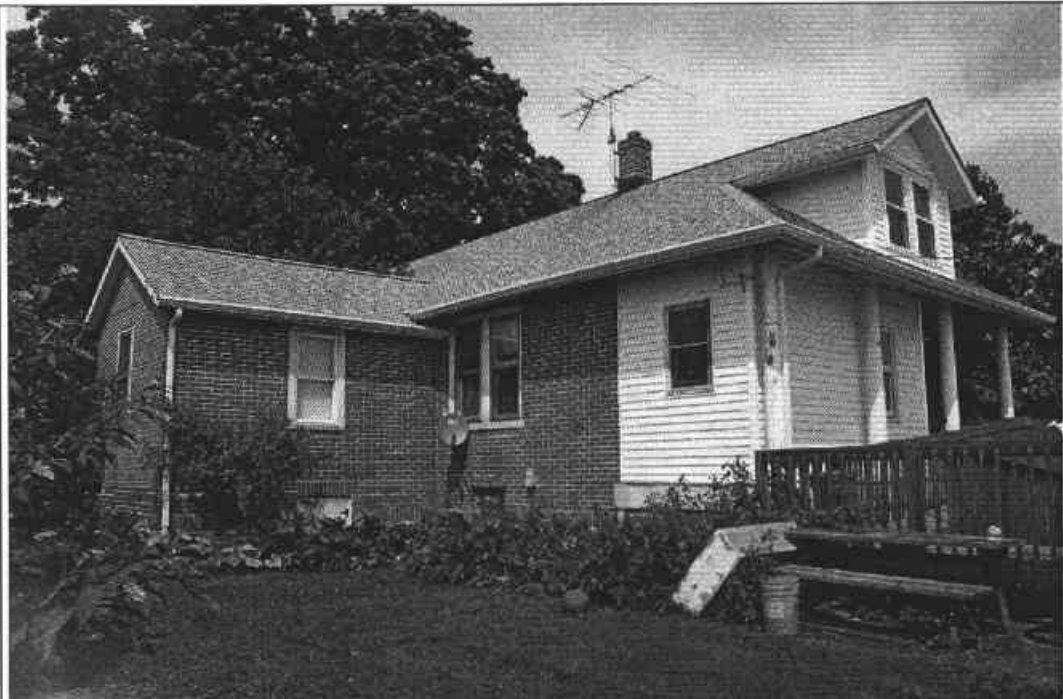
N12019. Photograph 1: Edward T. Pleasanton House, south and west elevations, view to northeast. Note *circa*-1990 rear addition and handicap accessible ramp.

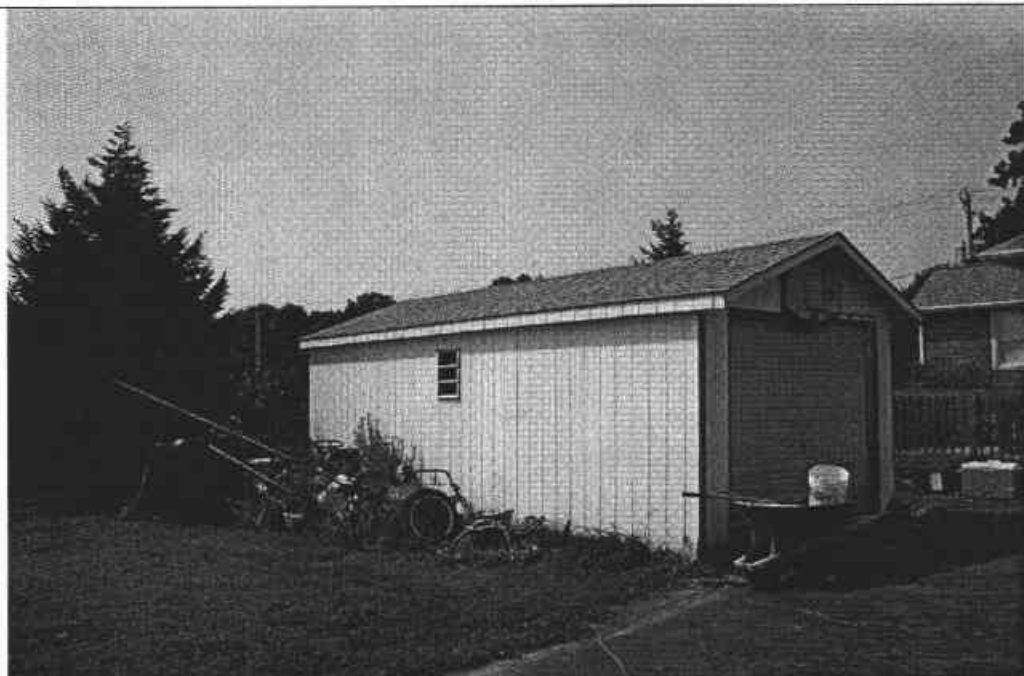
N12019. Photograph 2: Edward T. Pleasanton House, garage, south and east elevations, view to northwest. Note the overall condition of the garage, which has improved since the 1988 survey.

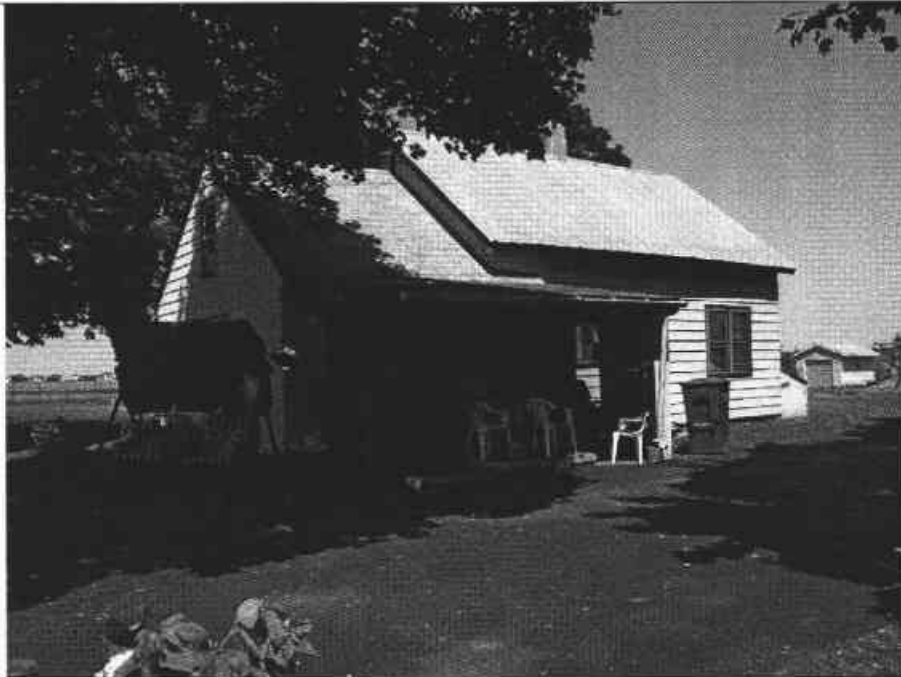
N12020. Photograph 1: Overview of former school from Churchtown Road. Note later addition to south elevation which altered integrity of form and paired replacement windows which altered integrity of fenestration.

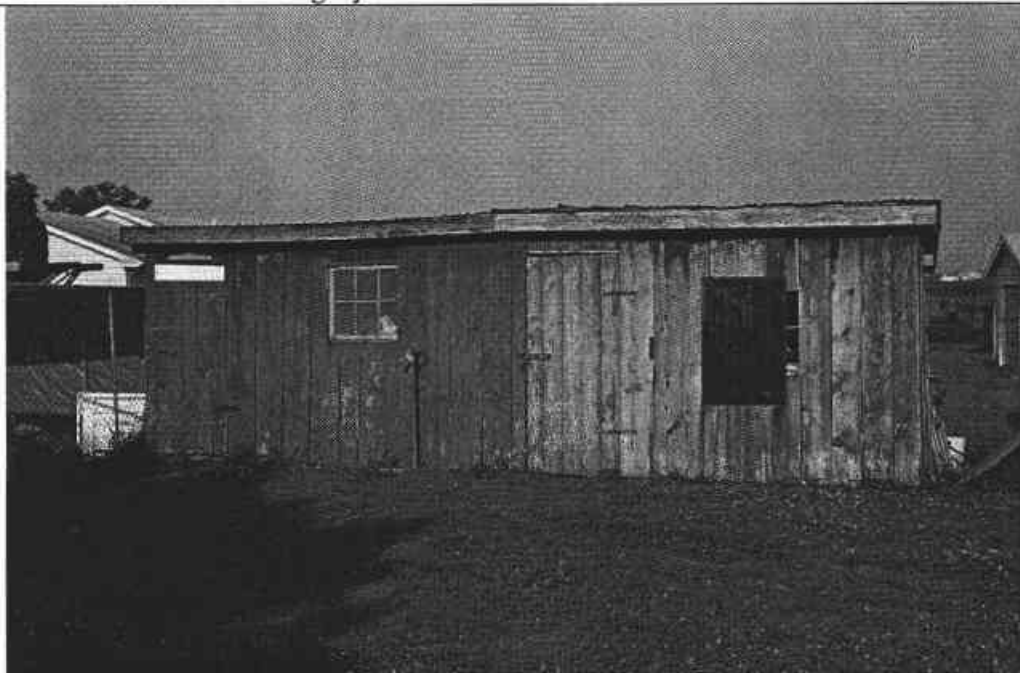
N12020. Photograph 2: Chicken house, east elevation, view to west. Note the fenestration pattern has been altered by the plywood covered window.

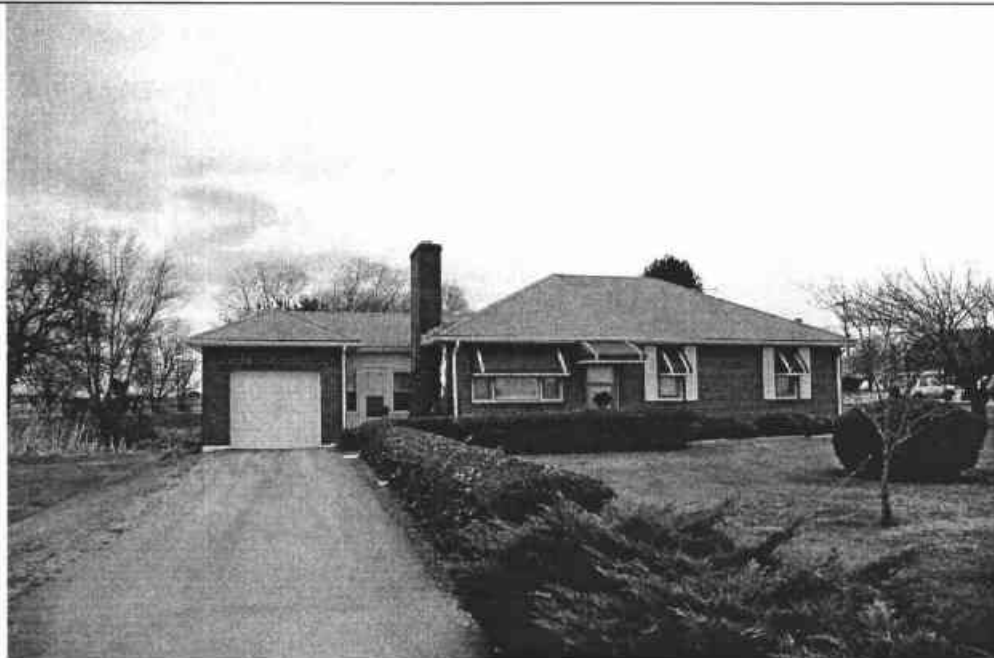
N12740. Photograph 1: Dwelling, 2110 South DuPont Highway, west elevation, view looking east. Note the hipped roof and original aluminum awnings.

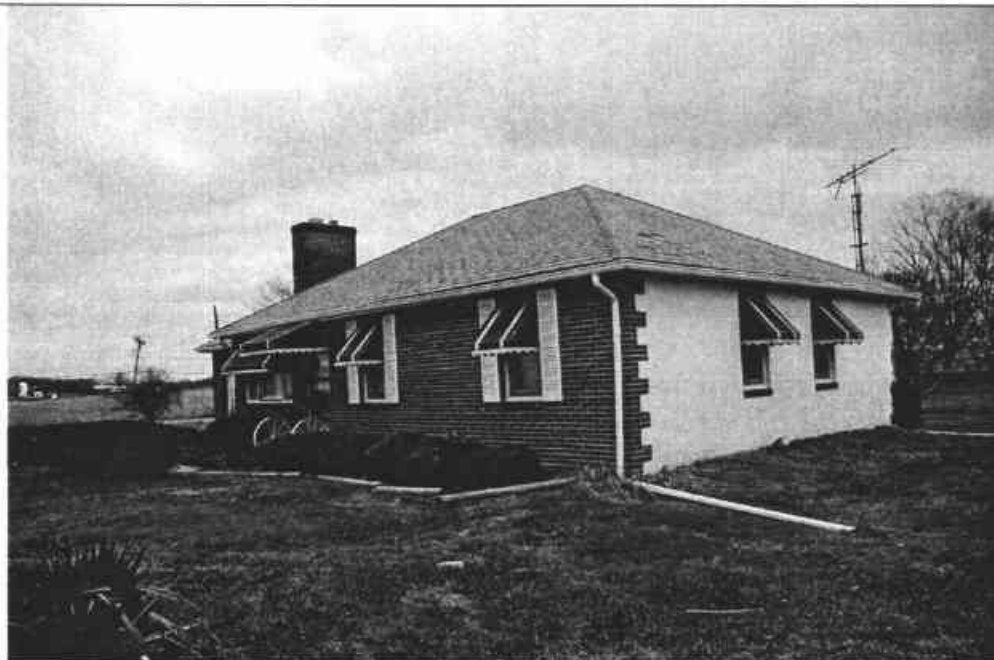
N12740. Photograph 2: Dwelling, 2110 South DuPont Highway, south and west elevations, view looking northeast. Note the coining, original aluminum awnings, as well as the stucco-clad south elevation.

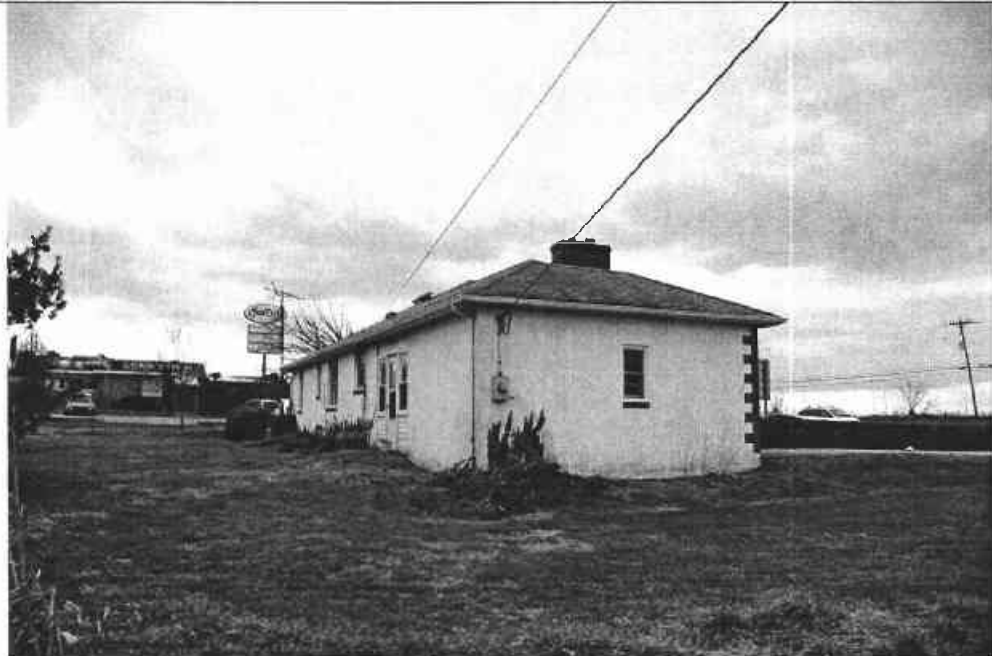
N12740. Photograph 3: Dwelling, 2110 South DuPont Highway, north and east elevations, view looking southwest. Note the lack of awnings.

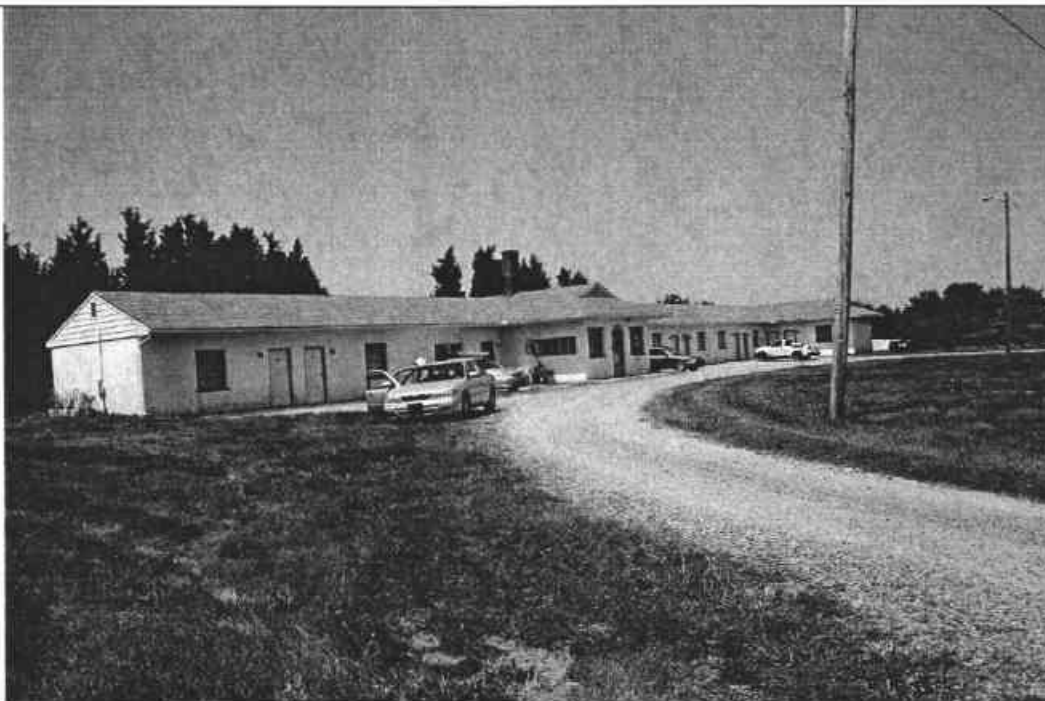
N012742. Photograph 1: South and east elevations of Parkway Motel, looking northwest, with office area near the center of photograph and later addition in the foreground.

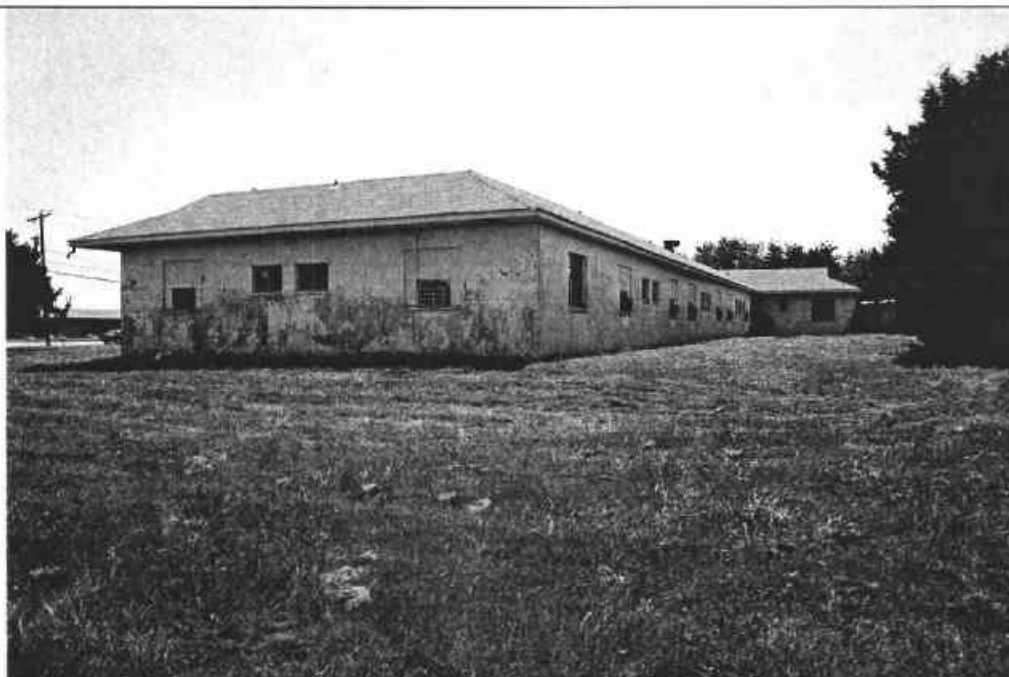
N012742. Photograph 2: North and west elevations of Parkway Motel, looking southeast. Note filled-in windows.

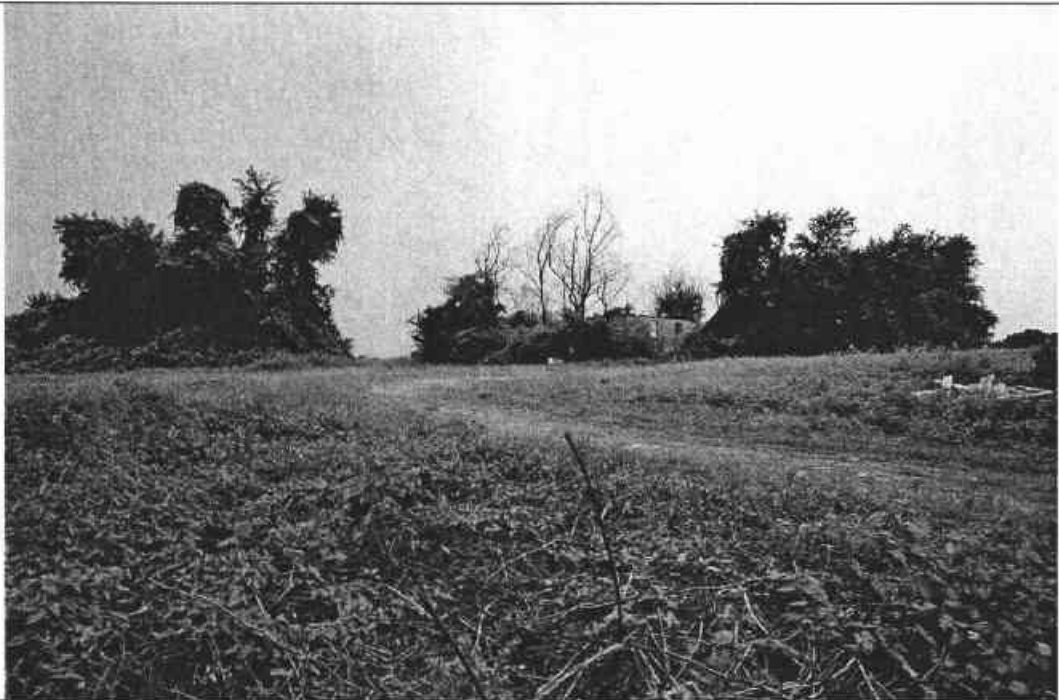
N12754. Photograph 1: J.H. Sutton Agricultural Complex, overview, view looking southwest. Note the clusters of trees where buildings likely once stood.

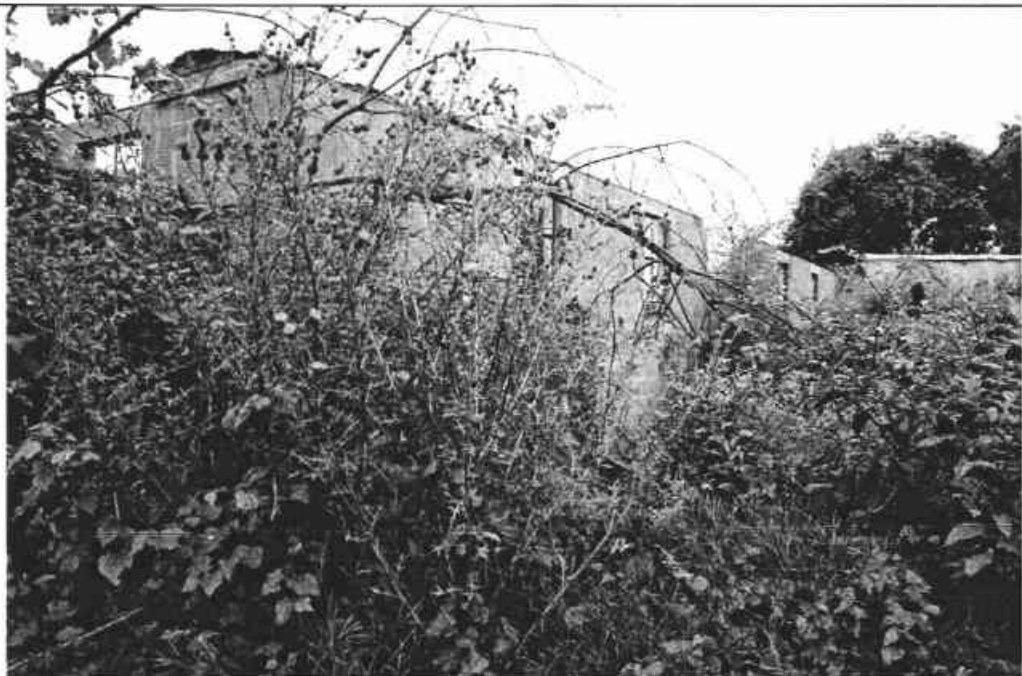
N12754. Photograph 2: Dairy barn, north and east elevations, view looking southwest. The concrete block first story is the only thing that remains of dairy barn following a post-1991 fire.

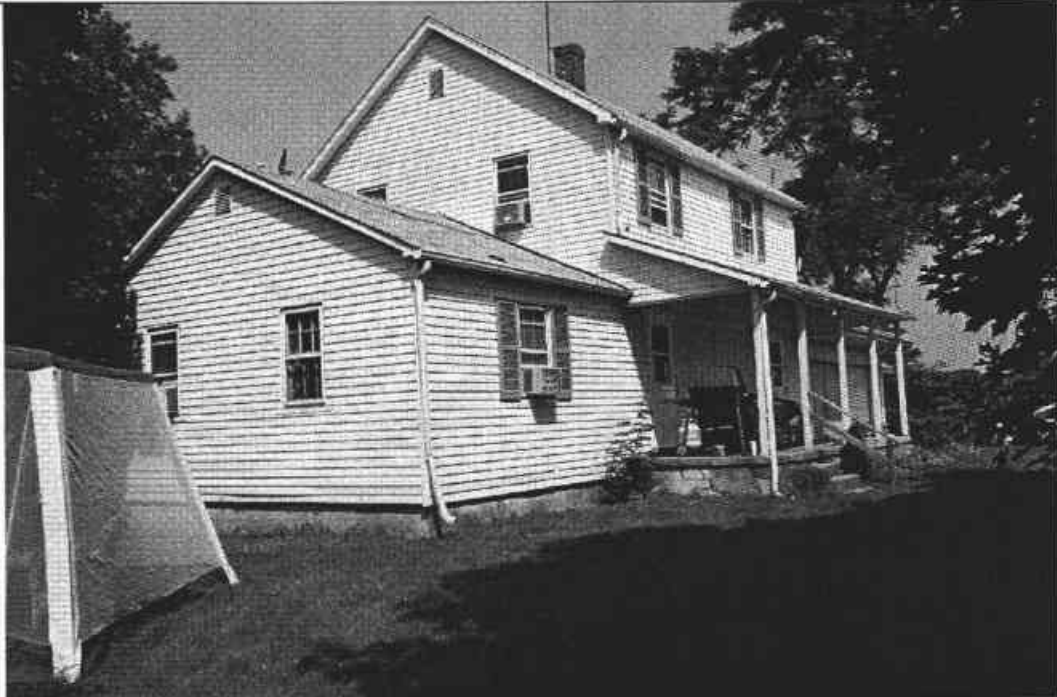
N012758. Photograph 1. Joy Run Farm. Overview of house, looking southwest, showing north and east elevations. Note two-bay garage addition in foreground of photograph.

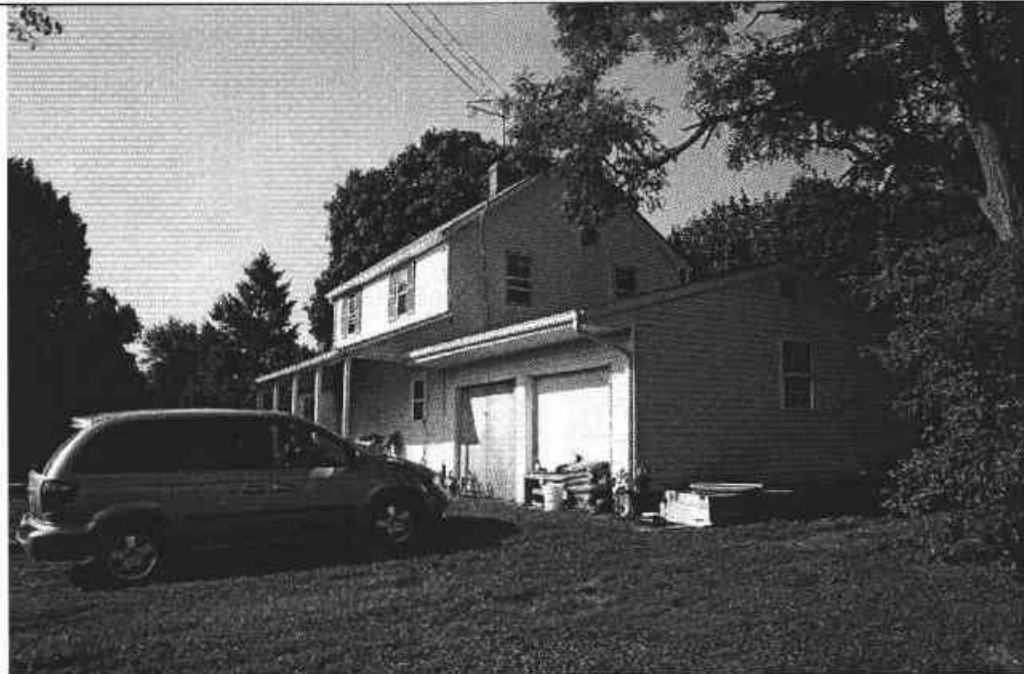
N012758. Photograph 2. Joy Run Farm. Overview of house, looking northeast, showing south and east elevations. Note addition to house in foreground of photograph.

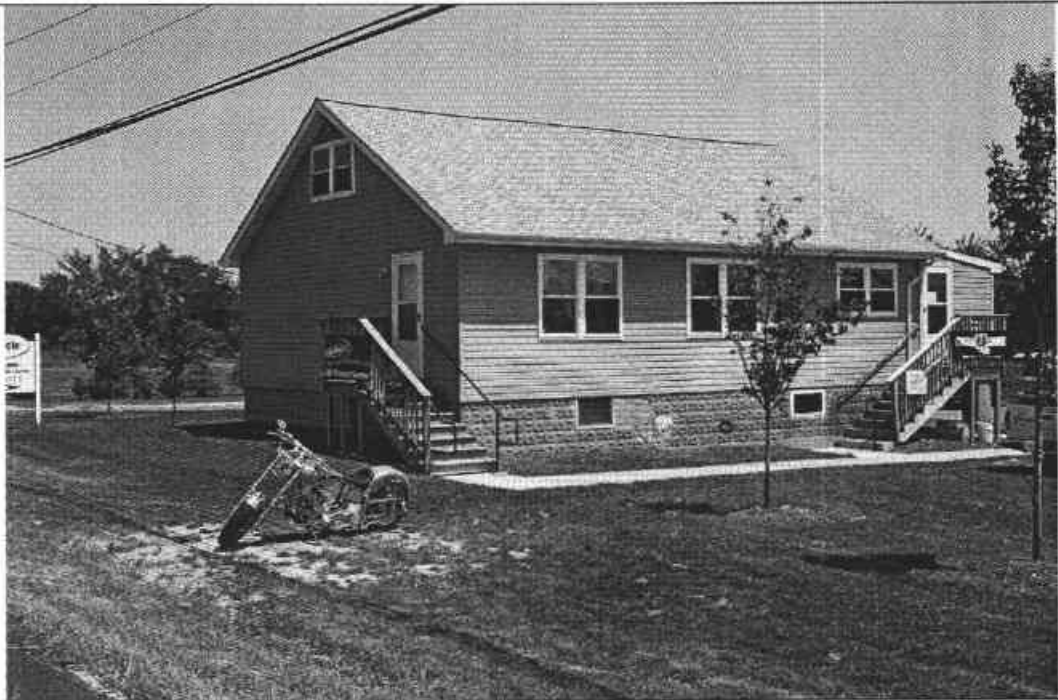
N13309. Photograph 1: Dwelling, west and south elevations, view looking northeast. Note replacement windows, vinyl cladding and the new pedestrian entry on the façade.
